## Silicon identification

This document applies to the STM32F078CB/RB/VB devices and their silicon revisions shown in [Table 1](#).

[Section 1](#) gives a summary and [Section 2](#) a description of device limitations, with respect to the device datasheet and reference manual RM0091.

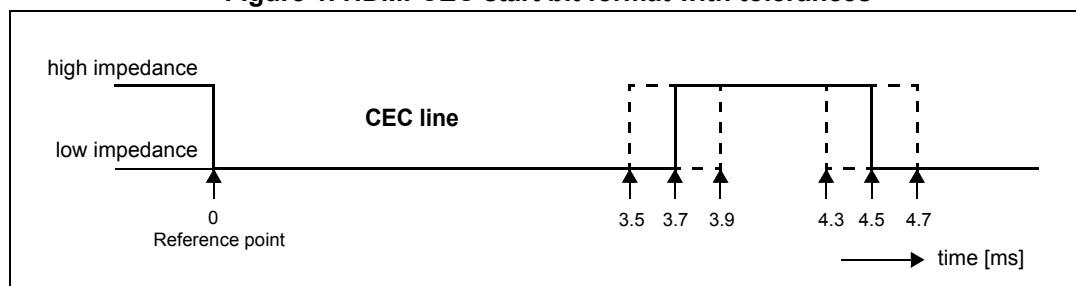
**Figure 1. HDMI-CEC start bit format with tolerances**

This failure is unlikely to happen as the CEC start bit corruption by another device can only occur if that device does not respect the CEC communication protocol.

The start bit timing standard tolerances are shown in [Figure 1](#). The start bit is initiated by the device by driving the CEC line low (reference point). After 3.7 ms, the device releases the CEC line and starts checking its level. The following conditions must be met for the start bit to be valid:

If one of these conditions is not met, the transmission is aborted and never automatically retried. No error flag is set and the TXSOM (Tx Start Of Message) bit is not cleared.

A way to work this limitation around is for the system-level CEC application software to start a time-out counter when setting TXSOM bit and stop it upon TXBR or TXEND event. In case of time-out, the HDMI-CEC functional block is disabled then enabled, by setting the CECEN bit in CEC\_CR register to 0 then to 1. This clears the TXSOM bit.
